Bellona Working Paper

Nuclear Andreyeva Bay

Alexander Nikitin

Date: November, 2009

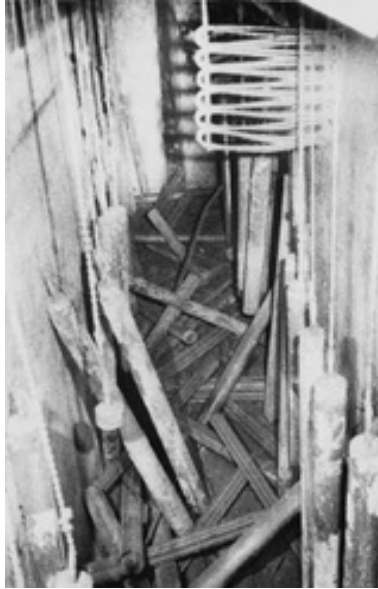
Heaps of SNF casks that fell to the bottom of the left-hand storage pool in Building 5 (Photo: Bellona archive).

Between March 1983 and early September 1987, the left pool of the SNF storage facility was being emptied of its contents. Spent nuclear fuel previously in storage was unloaded and shipped off to Mayak – all but those SFAs that had fallen to the bottom of the pool and remained there untouched.

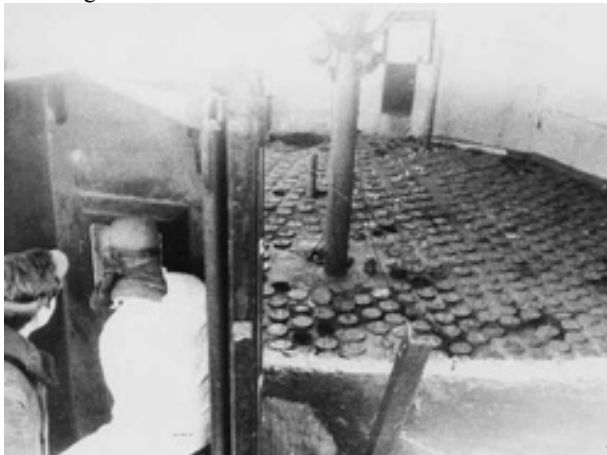
A protective screen was used to load Tanks 2A and 2B of the dry storage facility with SNF from Building 5. It turned out later that high levels of gamma radiation still led to severe exposure of the personnel hiding behind the shield as rays of radiation traveled around, reflected by the tank walls (Photo: Bellona archive).

The transportation was done according to the following scheme: The KrAZ truck, which carried the container with defective SFAs from Building 5, pulled up at the dry storage blocks and the contents of the container was reloaded into dry storage cells using a crane. A dry storage cell was basically a rusty pipe 4 meters high and with a diameter of 400 or 275 millimeters. After loading, the top of a cell was covered with a lid, which provided no air- or watertightness. The casks with SNF were either severely deformed from banging so badly at the steel bottom of the pool or totally destroyed by ice. Sometimes, fuel was spilling out of the SFAs as they were being reloaded, emitting gamma radiation at levels ranging between 800 and 17,000 roentgen per hour. A seaman recruit would pick up the spilled fuel with an ordinary shovel and a brush and pour it into the rust-covered pipes of the dry storage blocks. Such loading technology was apparently creating the conditions where a local critical mass would accumulate in the pipes and lead to a spontaneous chain reaction – or a nuclear flash. Such cases were also observed in Building 5.
